Final Report
for
Iowa Department of Transportation
Project HR-504

Galvanized Bridge Deck Reinforcing

December 1992

I-35 over Long Dick Creek
Story County

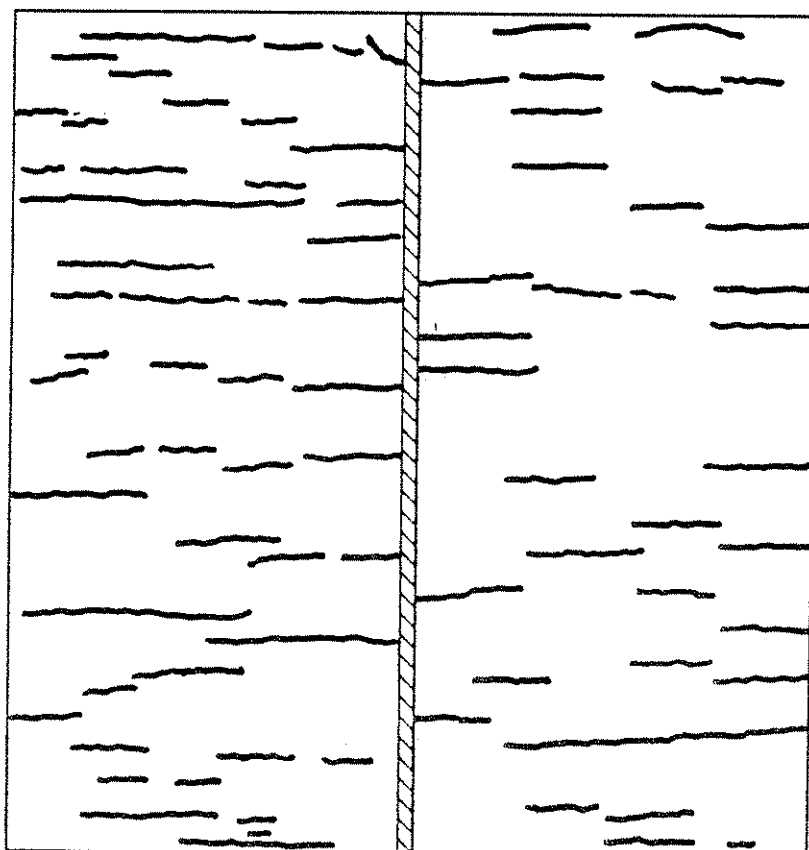
Concrete deterioration in the form of cracking was observed on exposed deck surfaces. Concrete cracking oriented in the transverse direction is shown in Figs. A.2.(g - i). In some instances, cracks occur over embedded steel reinforcement.

CRACKING IN
CONCRETE

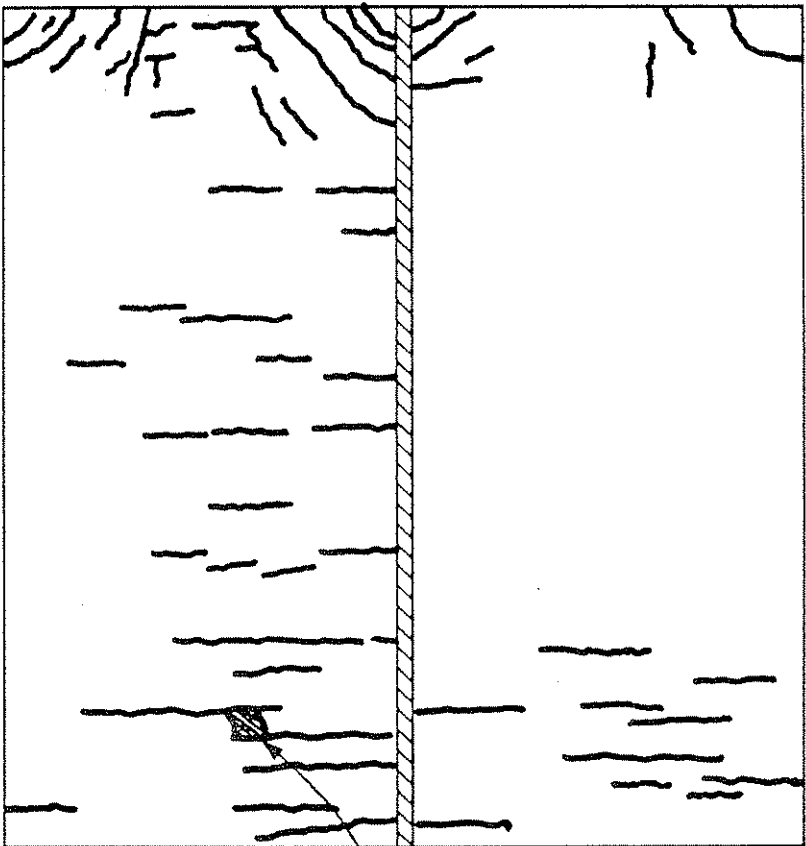
CRACKING IN
CONCRETE

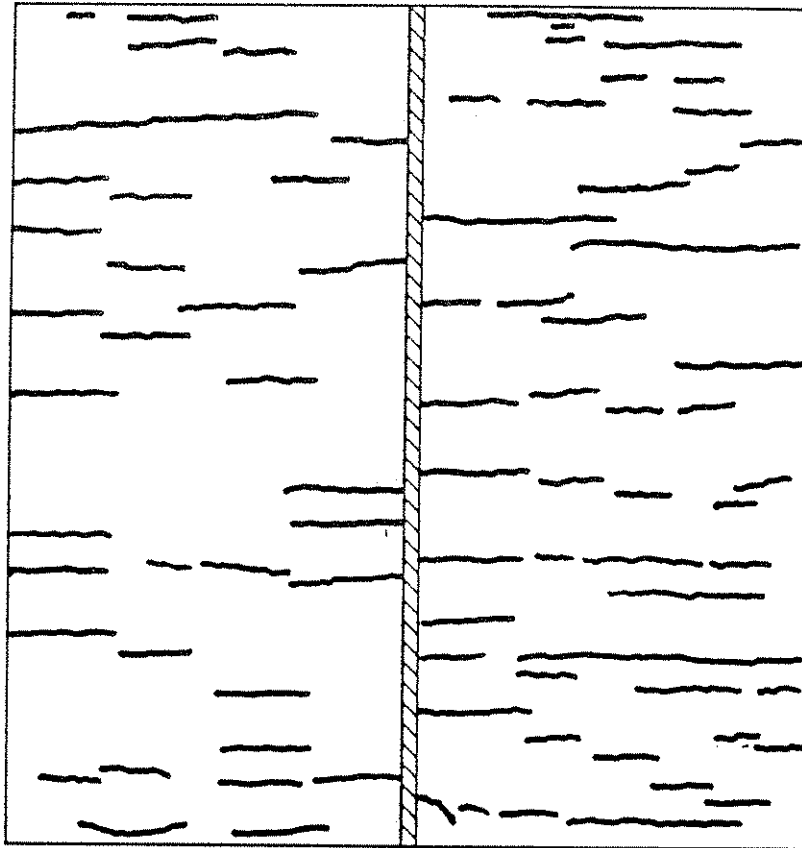
CRACKING IN
CONCRETE

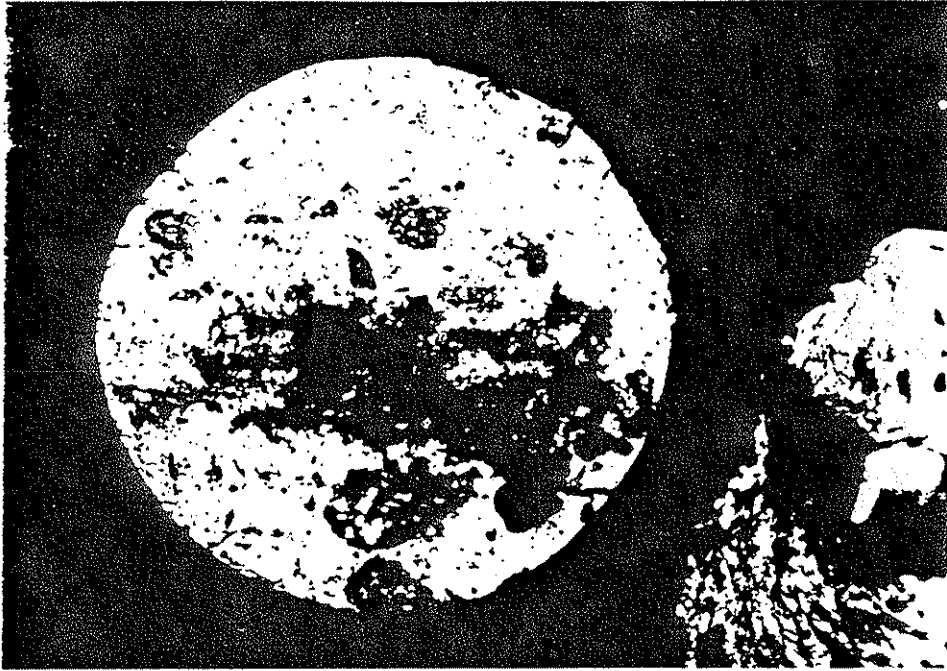
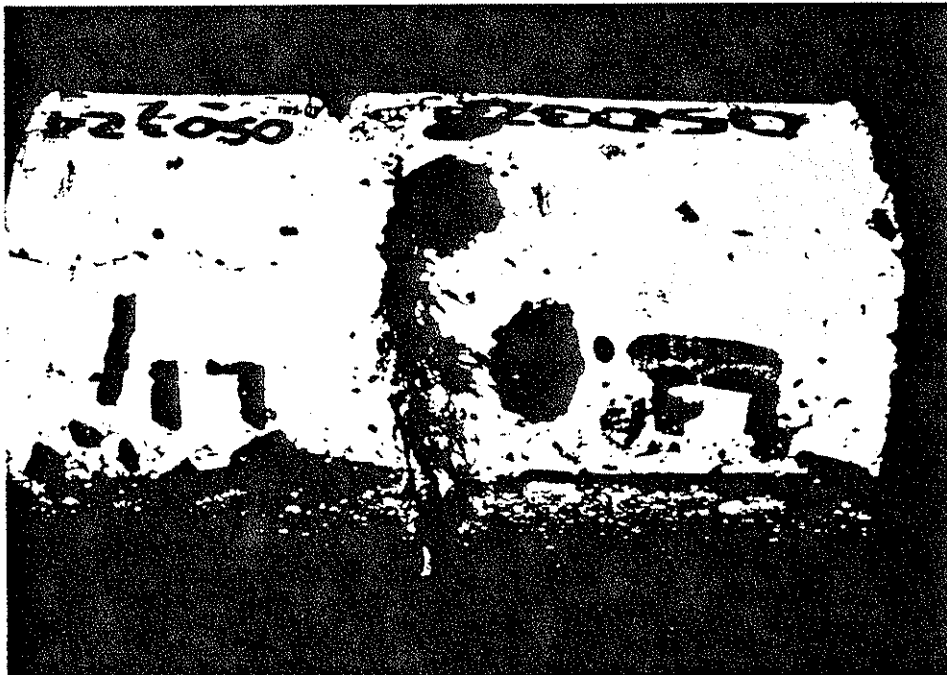
PHOTOS A.2(c & d):

Close-up Views of Core Sample L-1 Note that the water-soluble chloride ion content in powder sample L-1A was 0.257 (by weight of cement), at a depth of approximately 2-1/2-in. Potential survey results indicated a reading of -170 mv in adjacent concrete.

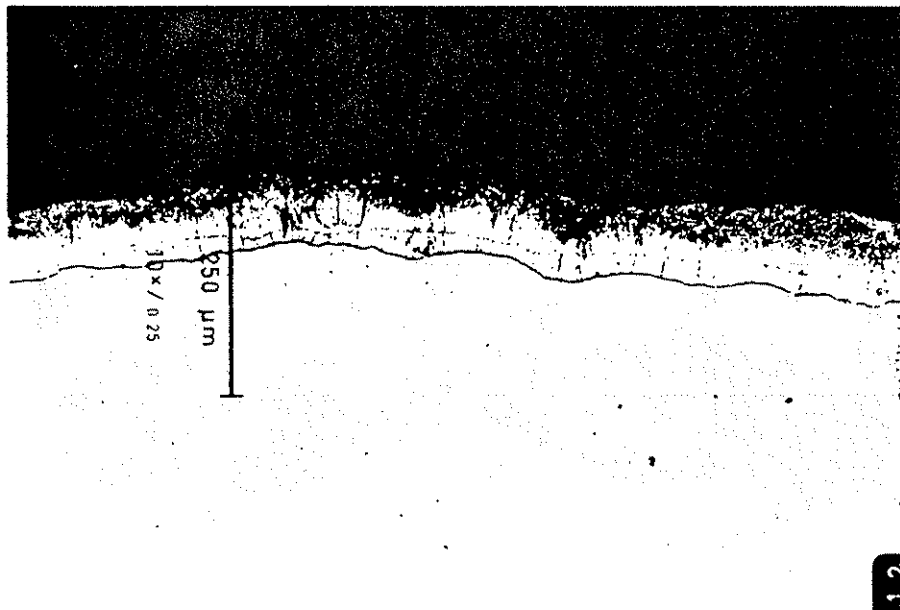
PHOTO A.2(f):

Magnification of No. 6 Bar removed from Core Sample L-6 (galvanized coating thickness of 3.8 mils).

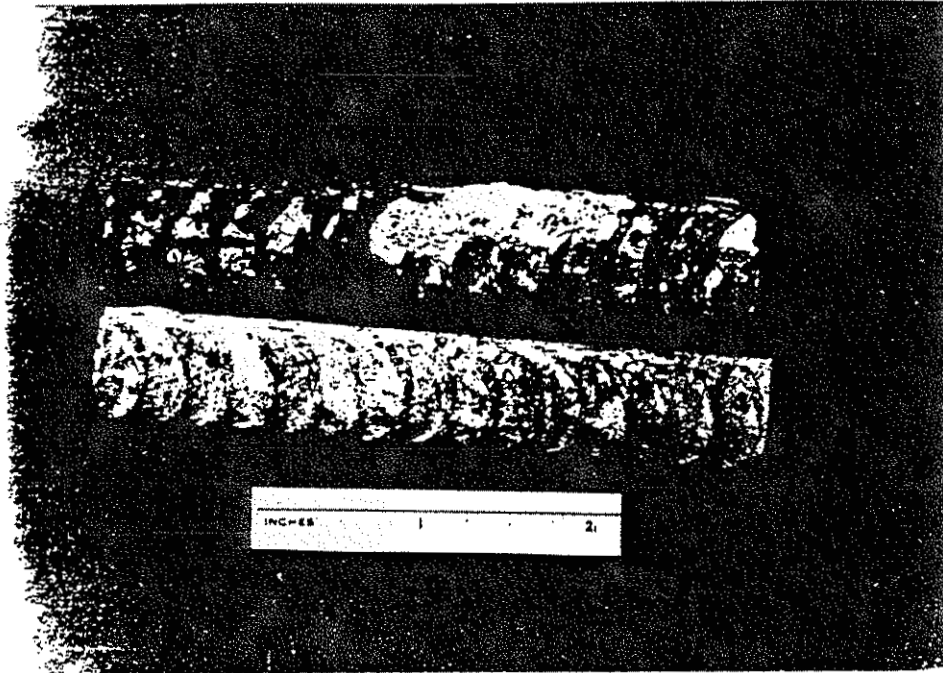
PHOTO A.2(g):

Cores L-10 and L-14 exhibited vertical cracks and corrosion on steel reinforcement (reference Table A.2). In addition, microcracking was observed around chert and dolomitic chert, which are reactive fine aggregates that can cause internal concrete deterioration.

Core L-10: Core sample shows a direct comparison between a coated bar (No. 5) and an uncoated steel bar (No. 6). The slightly ragged surface profile of the galvanized coating indicated that slight attack has taken place, although the coating still averages approximately 4.7 mils thick. The uncoated bar, which has a greater depth of concrete cover than the galvanized bar exhibits red rusting over almost half of its length.

Steel samples removed from Core Sample L-10.

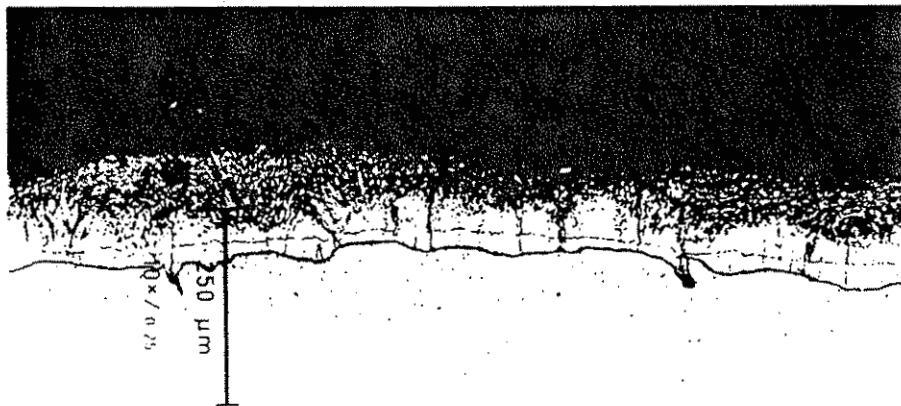
PHOTO A.2(h):

Magnification of No. 5 Bar removed from Core Sample L-10 (galvanized coating thickness of 4.7 mils).

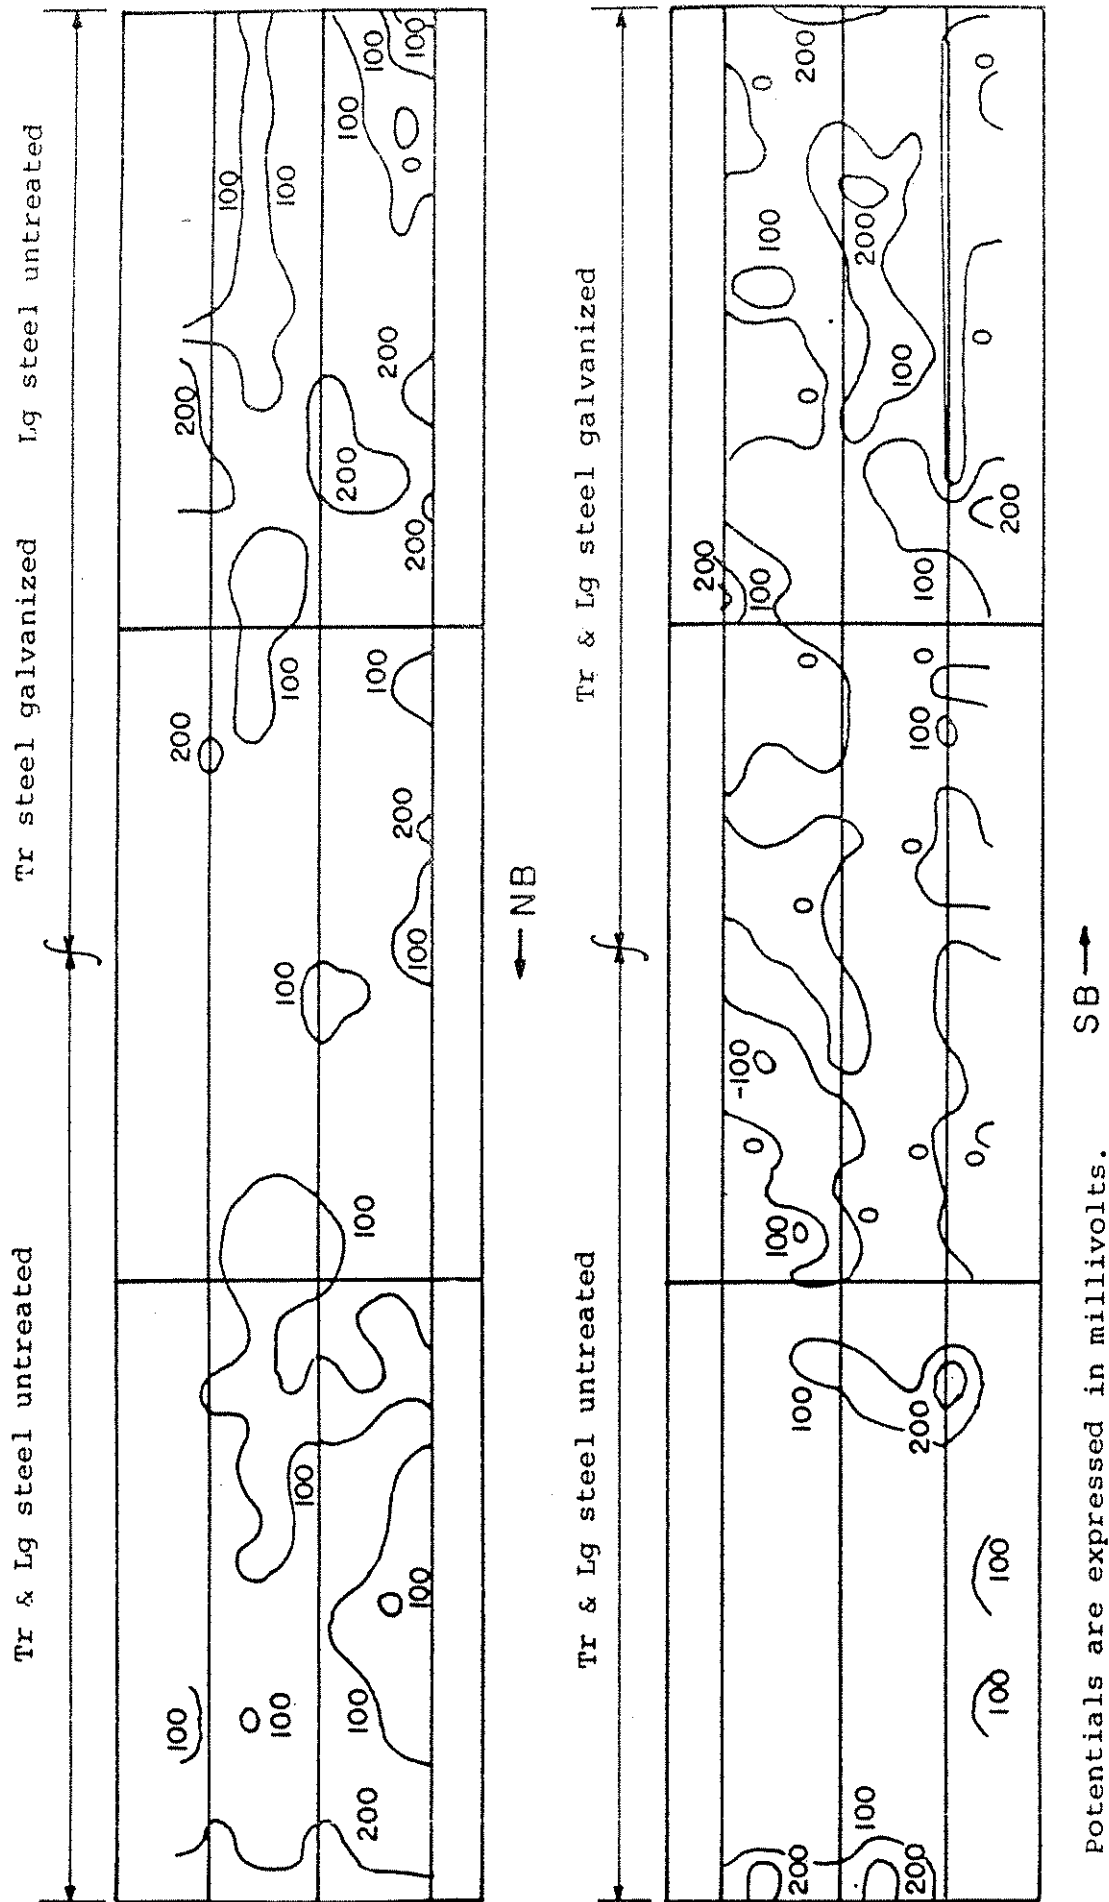
Fig. 22 - Diagram of distribution of electrical potentials in top mat of reinforcing steel.

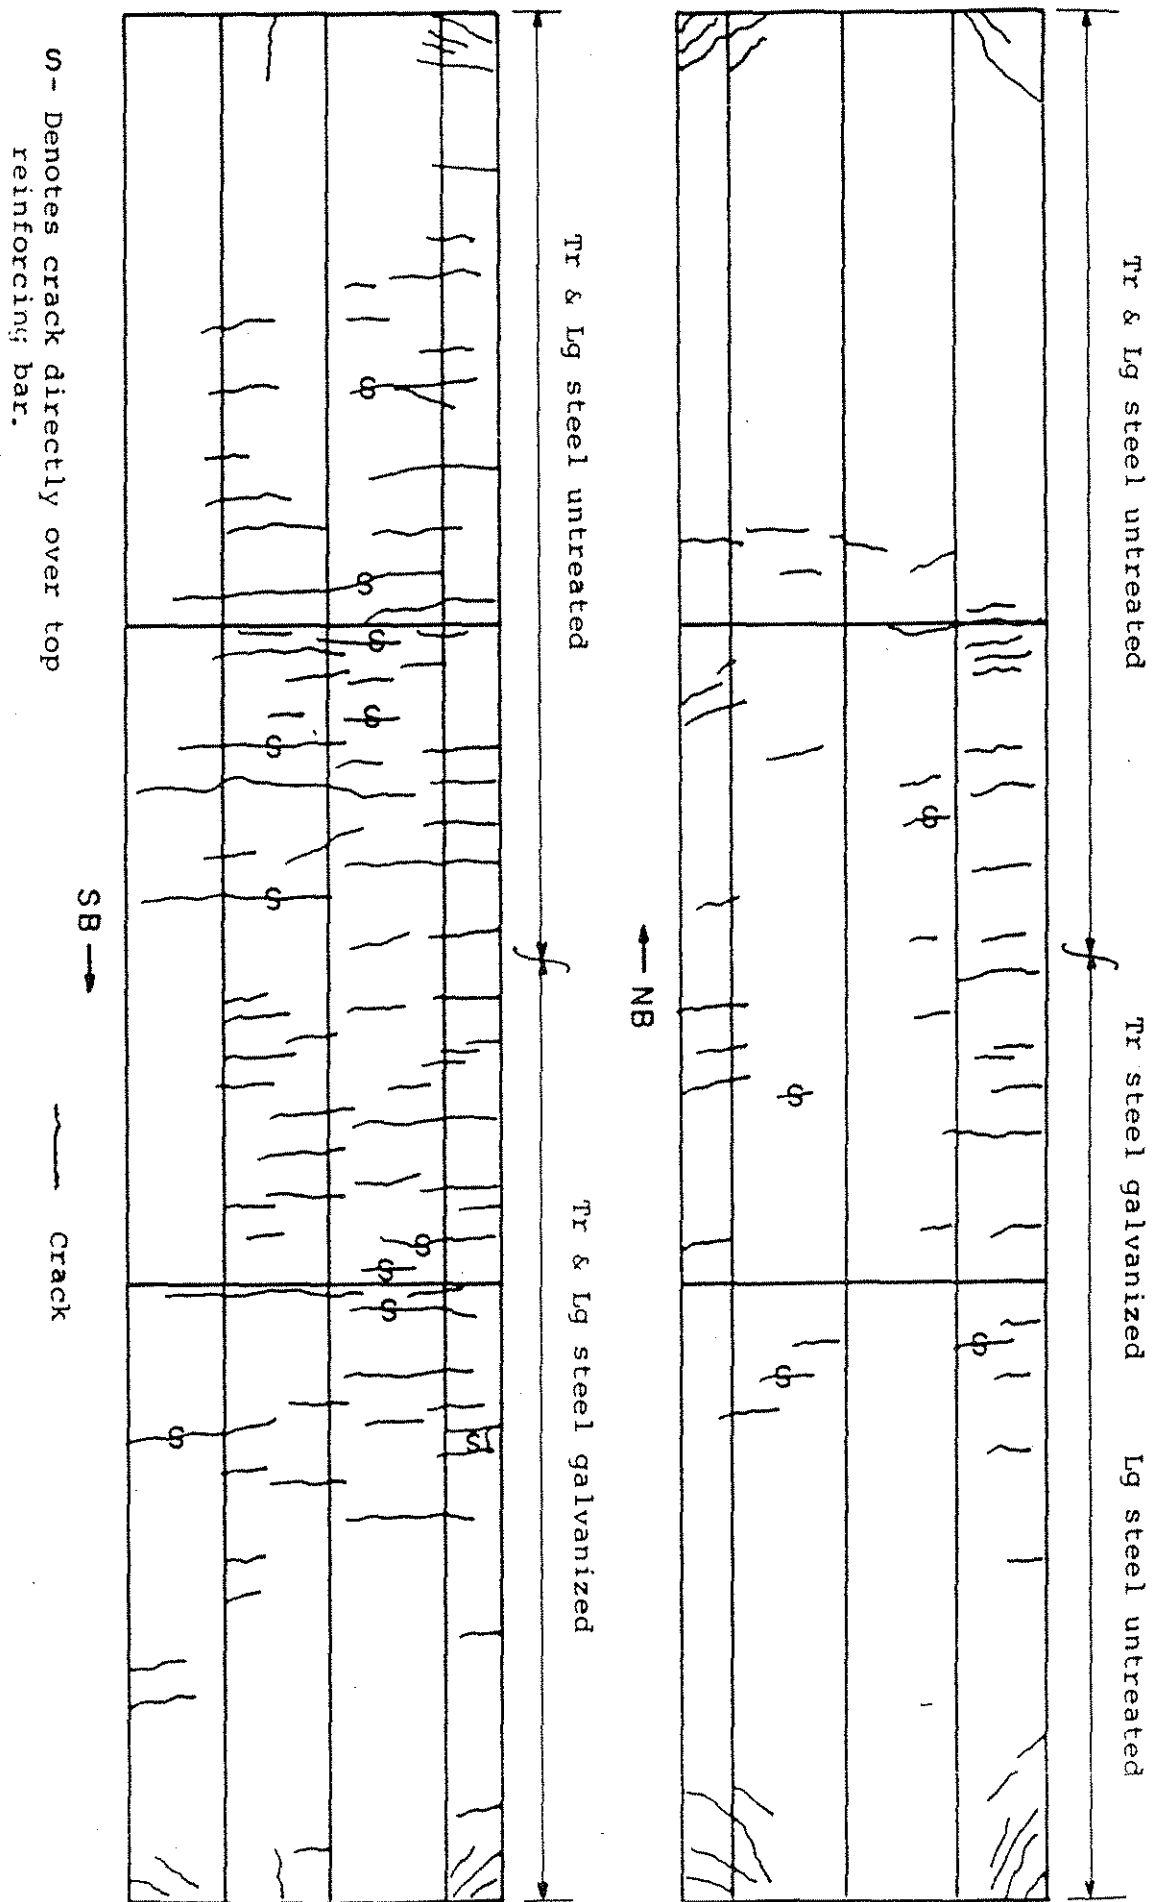
Fig. 23 - Diagram showing locations of cracks visible at wearing surface.
